Hydrologic Data Collected During the 1994 Lake Mills Drawdown Experiment, Elwha River, Washington

U.S. GEOLOGICAL SURVEY
Water-Resources Investigations Report 99-4215

By DALLAS CHILDERS, DAVID L. KRESCH, STEVEN A. GUSTAFSON,
TIMOTHY J. RANDLE*, JAMES T. MELENA*, AND BRIAN CLUER#

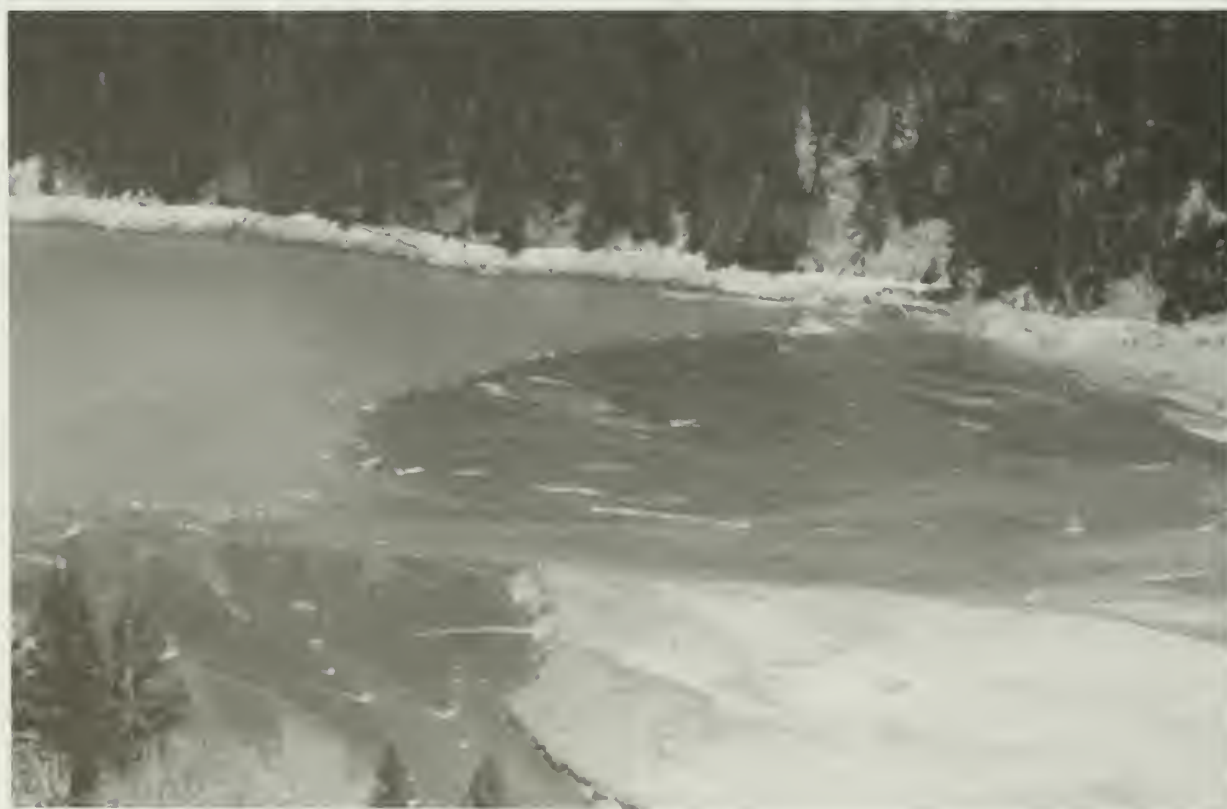
Figure 16. New delta forming immediately downstream of toe of the exposed older delta.

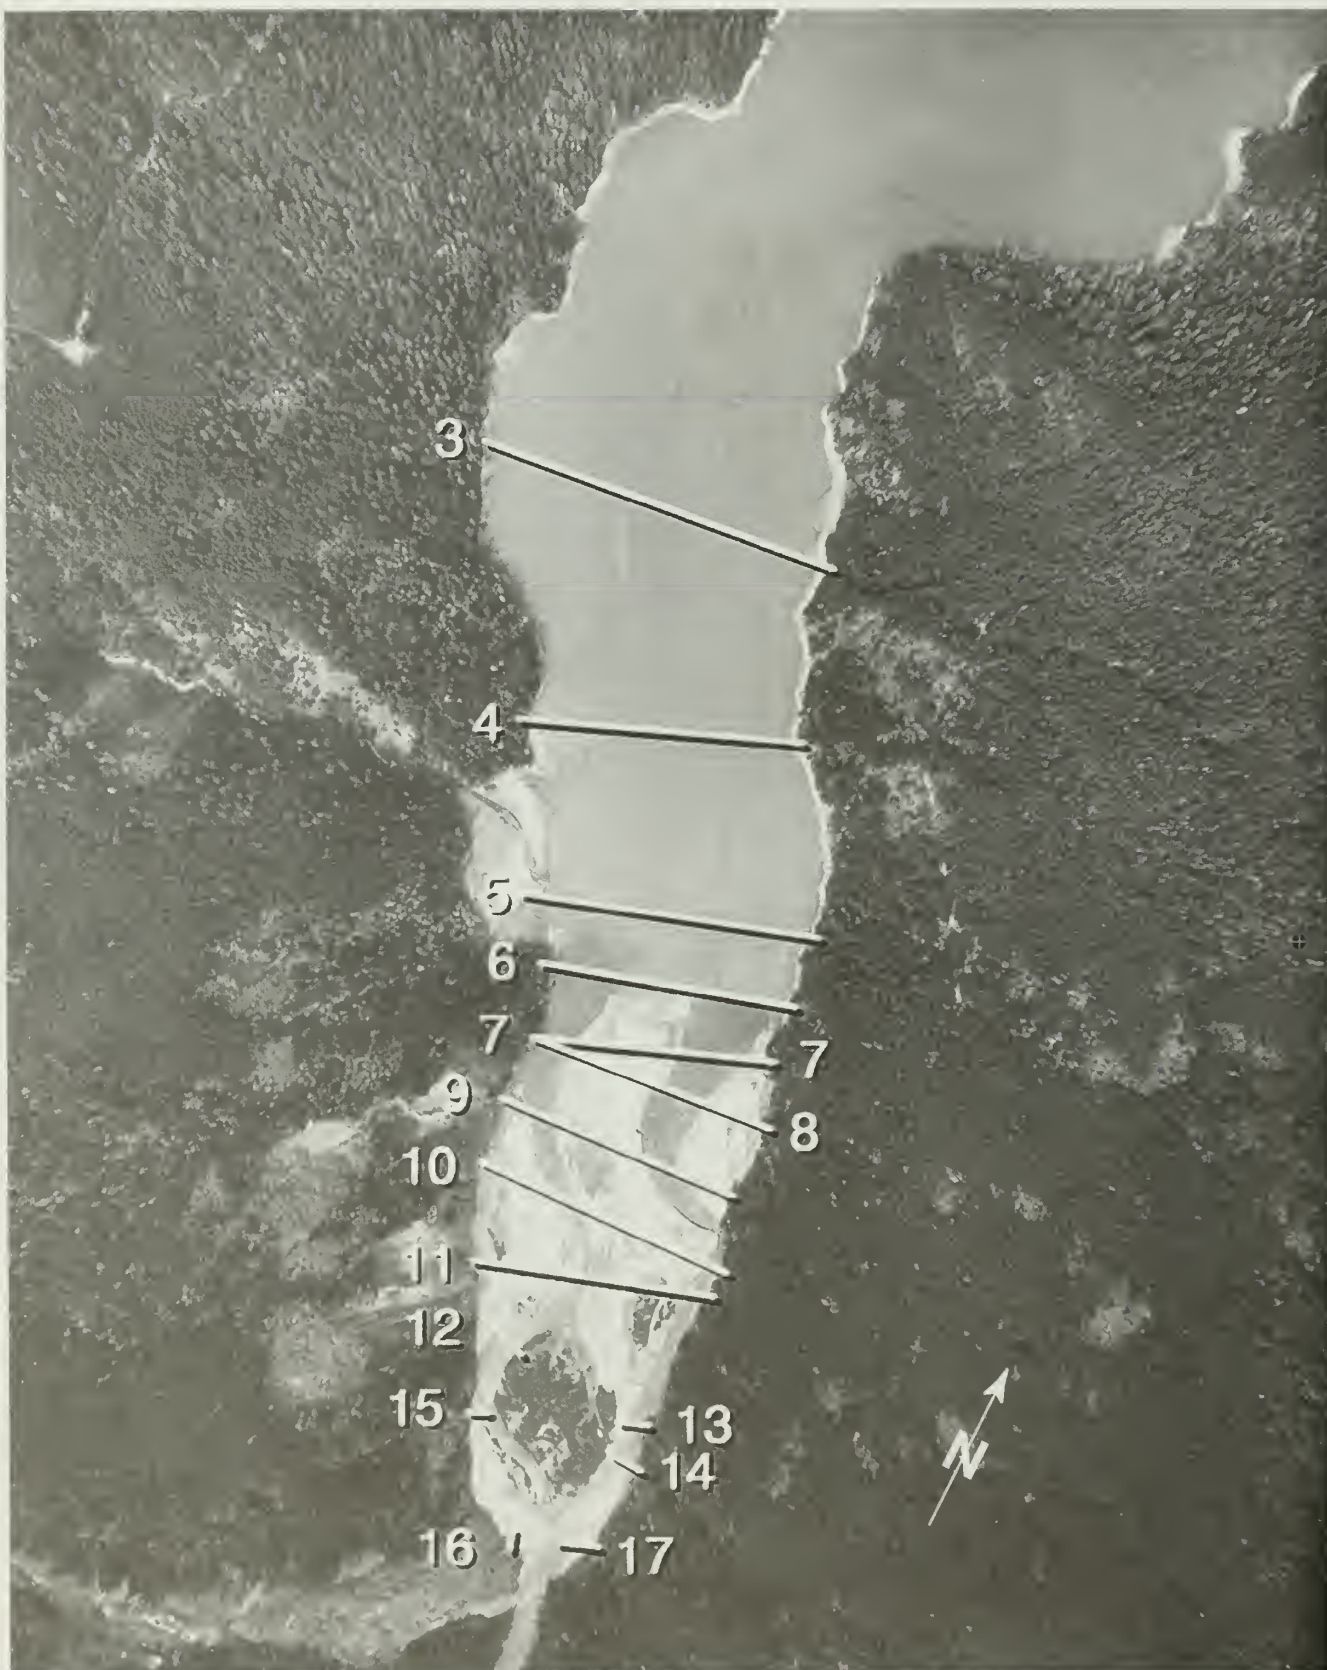
Figure 17. Locations of cross sections 3 through 17 surveyed on the Lake Mills Delta. Aerial photograph was taken at time of full reservoir drawdown on April 16, 1994. Photograph provided by the Bureau of Reclamation.

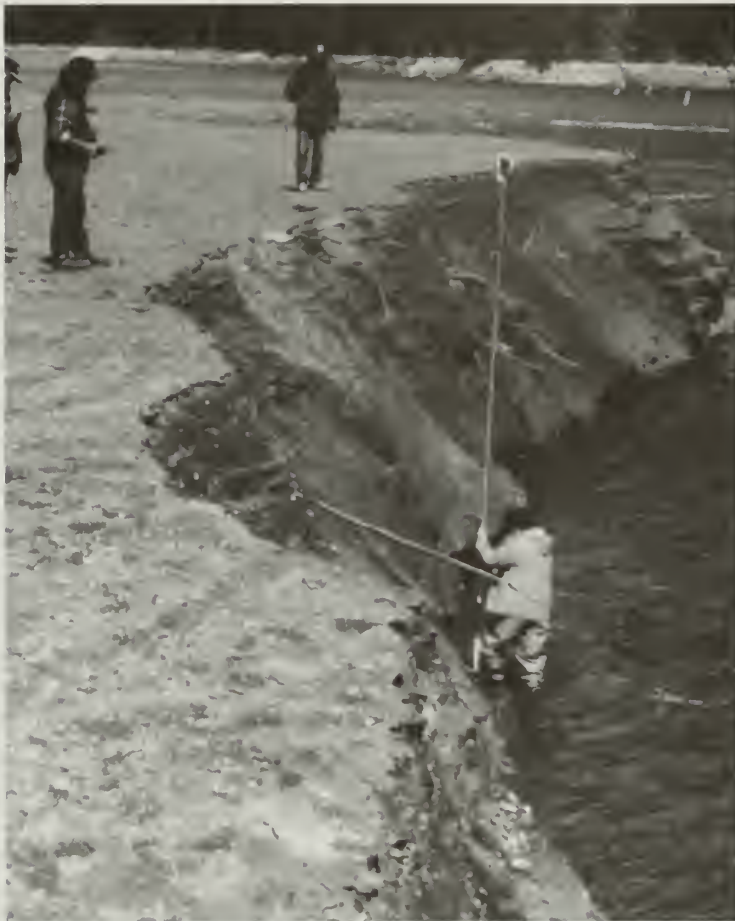
Figure 18. Land survey, with a total station and prism, of a Lake Mills Delta cross section.

An electronic total station referenced to three control points was used for the land surveys. One of the control points was used for the instrument setup location, from where the downstream two-thirds of the delta could be seen, and the other two were used as backsites. The position of the instrument was verified

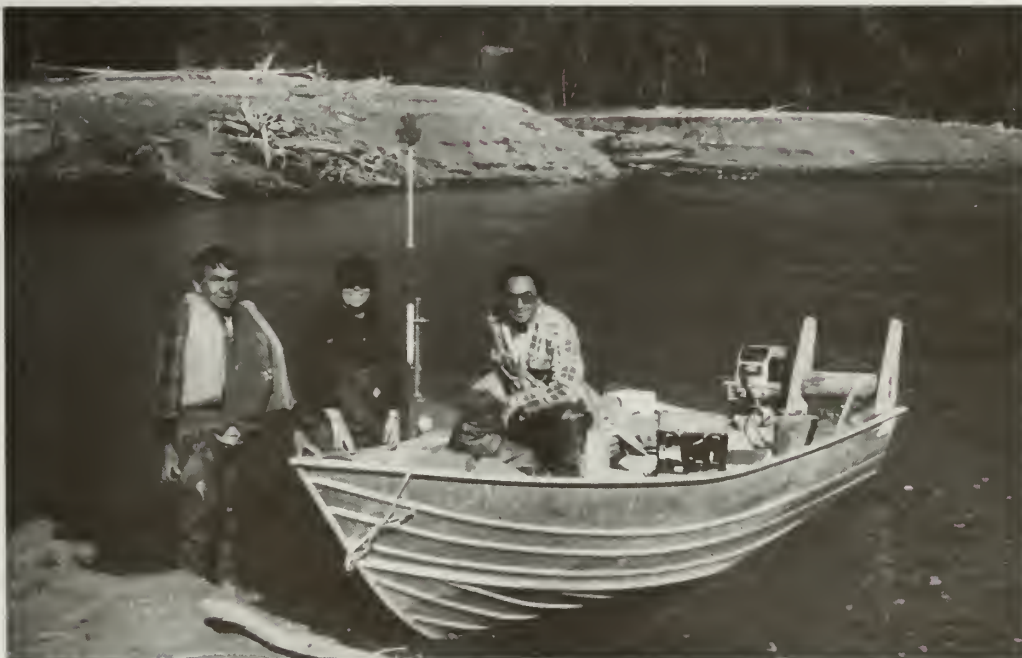
Figure 19. Bathymetric survey crew from the Lower Elwha Klallam Tribe and boat used to survey, with an electronic distance meter and fathometer, Lake Mills Delta cross sections that were too deep to wade.

The initial conditions of the eight most downstream cross sections were surveyed by boat on April 8, 1994. Depths were sounded and recorded with a fathometer, and horizontal distance was measured by an electronic distance meter (EDM) set up on shore over each cross section's west (left bank) monument. The EDM readings were relayed by radio to the boat and recorded on the fathometer chart. Bathymetric cross-section surveys were repeated daily from April 10 through April 26, 1994.

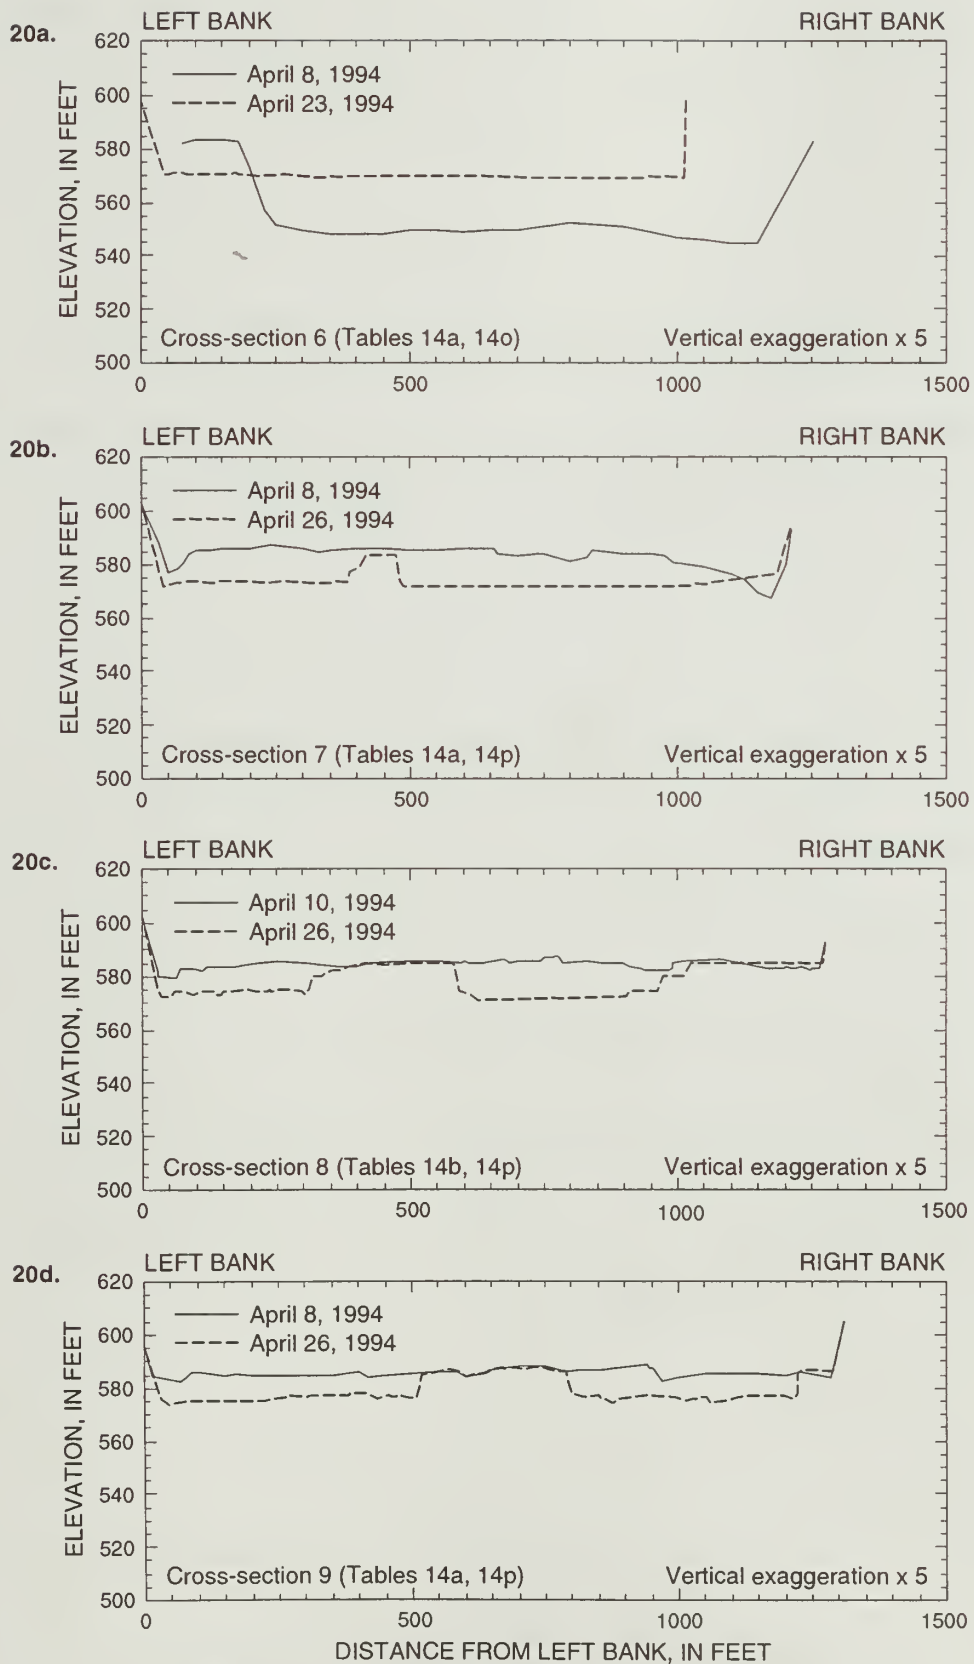
Figure 20a-d. Surface elevation of Lake Mills Delta, cross-sections 6-9.

The volume of Lake Mills Delta sediment that was eroded and transported during the drawdown experiment was estimated from the changes in cross-sectional area and the distances between cross sections to be about 300,000 cubic yards. Cross-section plots of the lower delta and lake were used to determine where degradation stopped and aggradation began. Eroded sediments were deposited farther downstream, extending the delta about 300 feet farther into the lake.

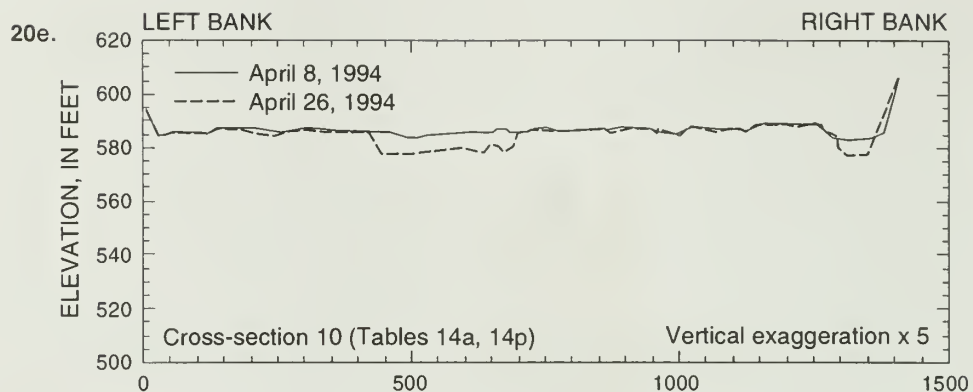
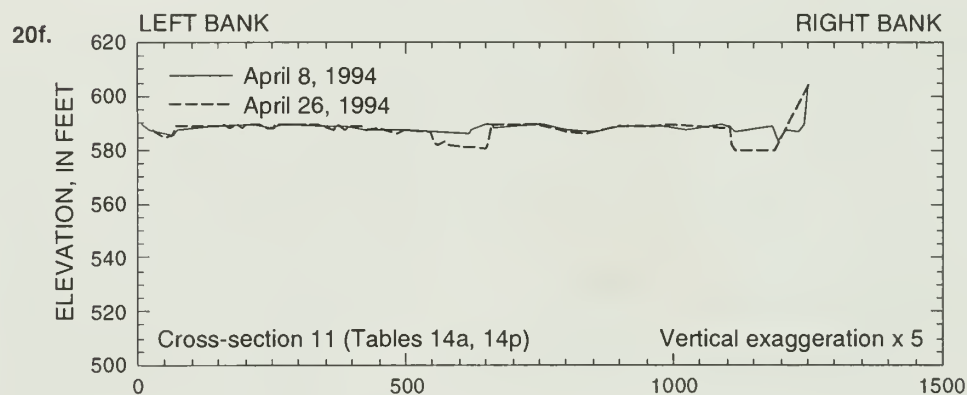
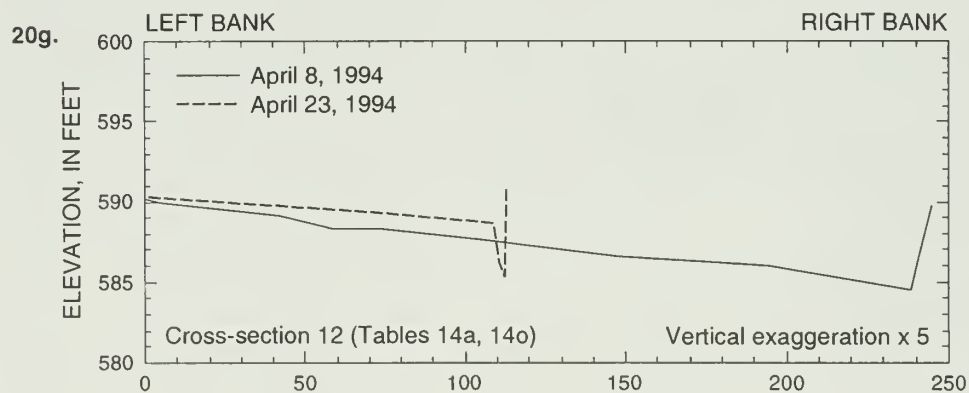
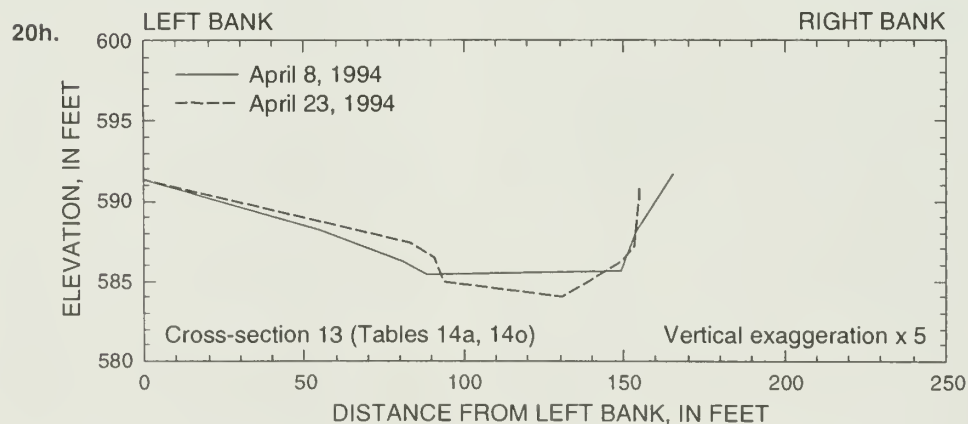
Figure 20e-h. Surface elevation of Lake Mills Delta, cross-sections 10-13.

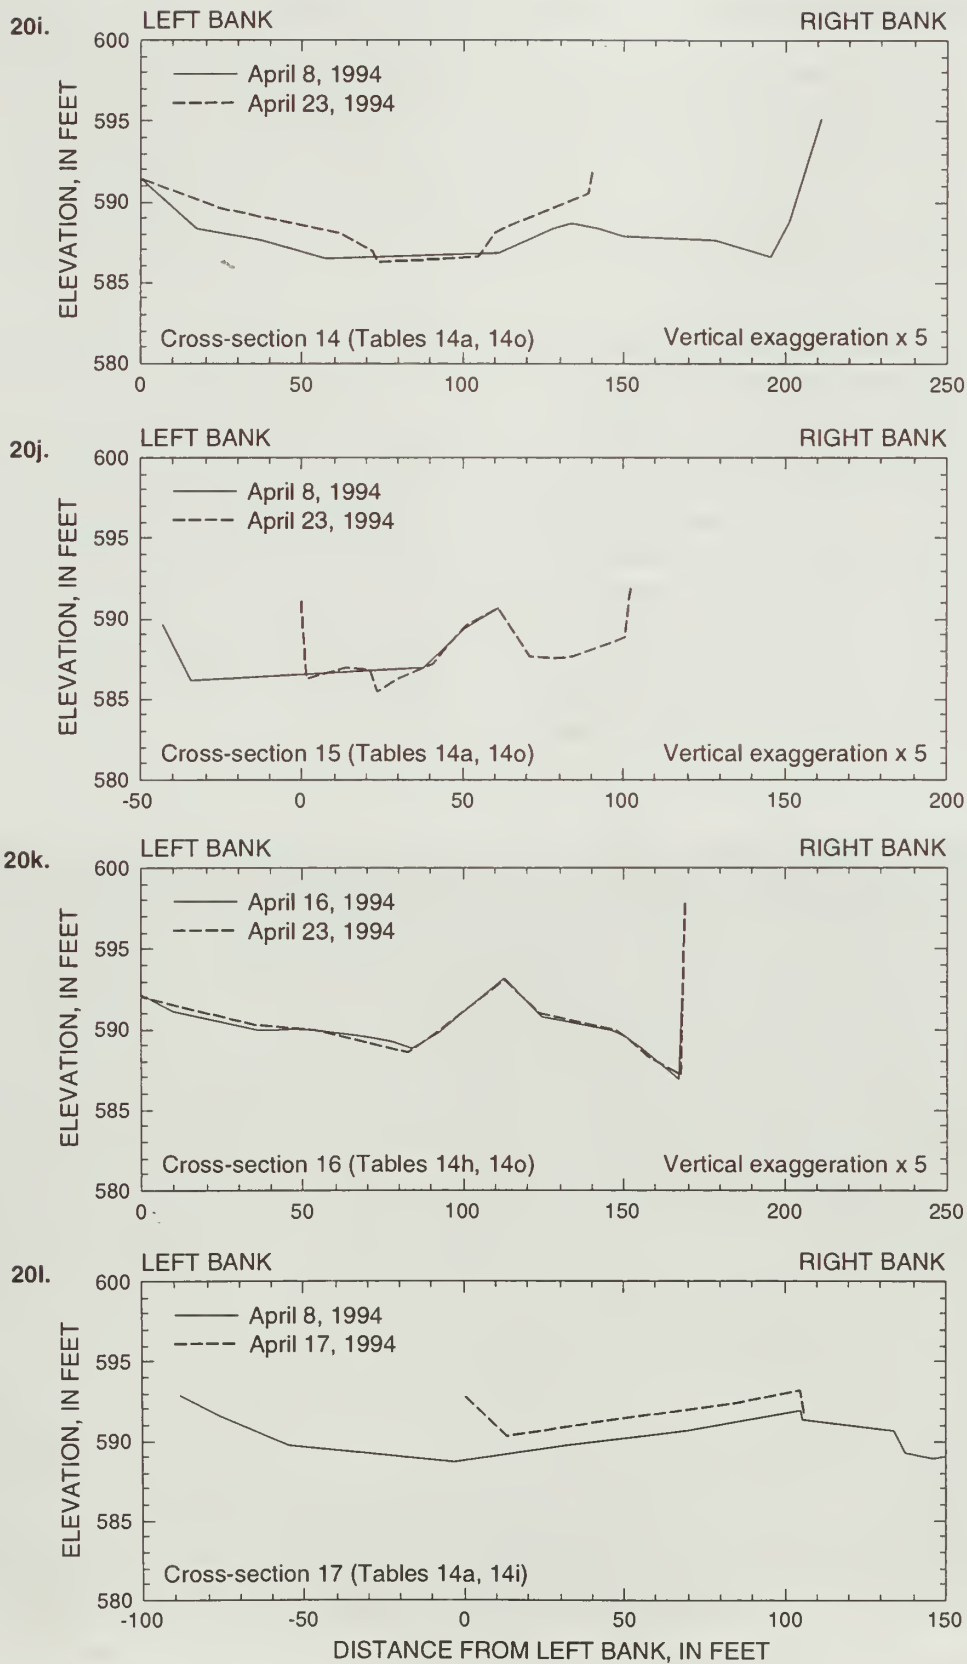
Figure 20i-l. Surface elevation of Lake Mills Delta, cross-sections 14-17.

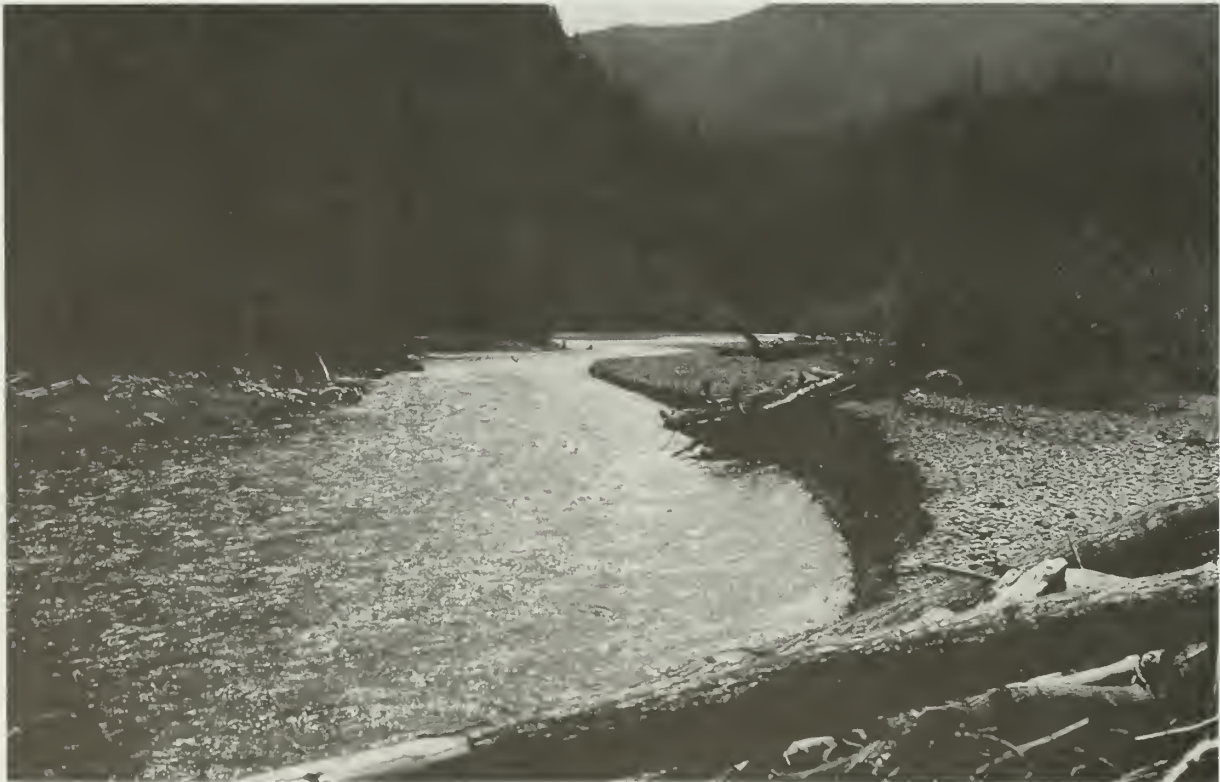
Figure 21. Upstream reach of the right channel near site 12044910, Elwha River Delta site 1 at Lake Mills (ELD1), looking upstream toward the head of the riffle.

During the course of the drawdown experiment, streambed erosion in the upper reaches of the left and right channels proceeded slowly and uniformly (photo, fig. 21). Nick points (points in the streambed where degradation begins) in both channels proceeded upstream but never reached the head of each riffle at the upstream end of the island separating the channels near the mouth of Rica Canyon. Bank erosion in the upper reaches of these two channels was limited to some degree by the abundance of logs and other woody debris from past floods deposited at the upstream end of the island and along the banks of the right channel. In the gravelly and cobbly upper part of the delta, erosion was primarily vertical during the entire experiment. As erosion continued, the bed became coarser, erosion slowed, and upstream progression of the nick points slowed.

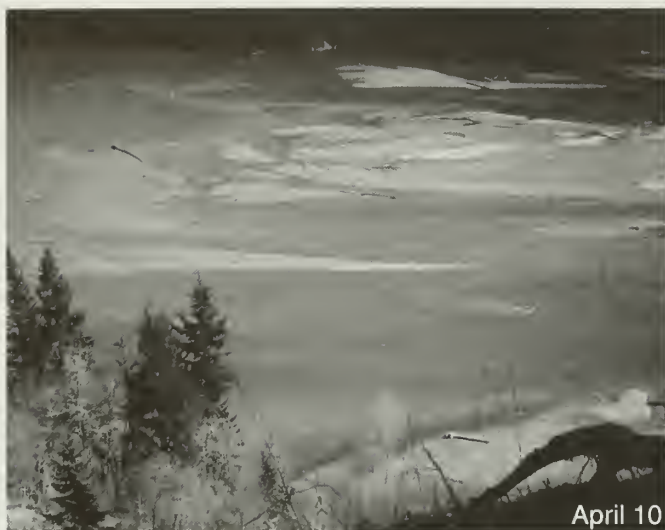
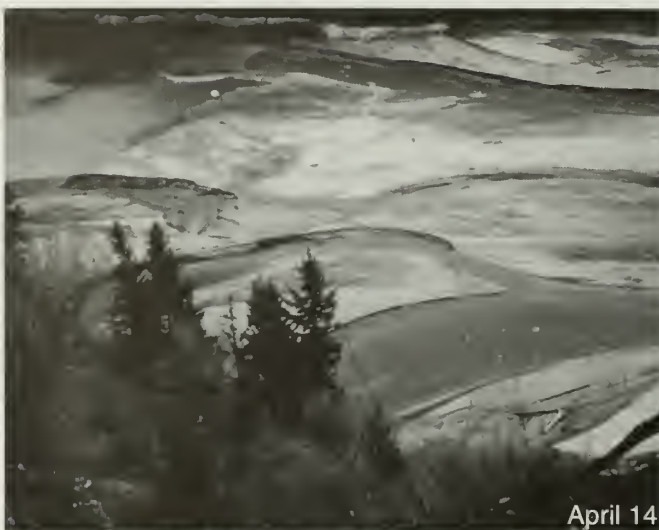
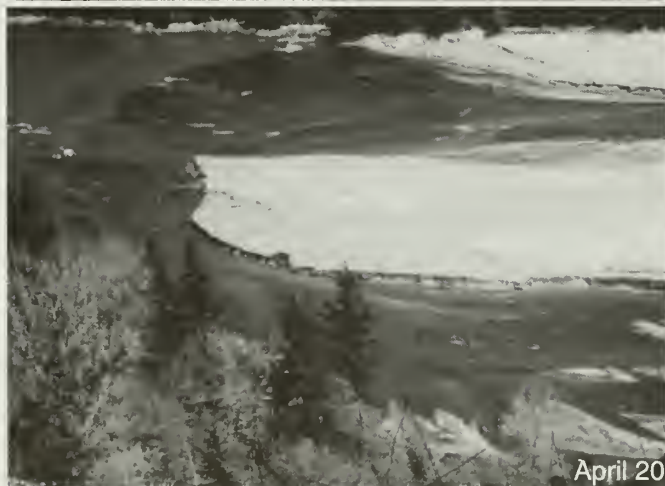
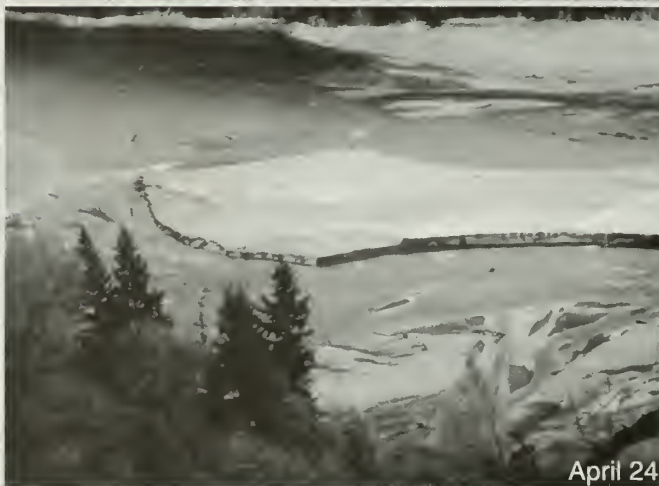
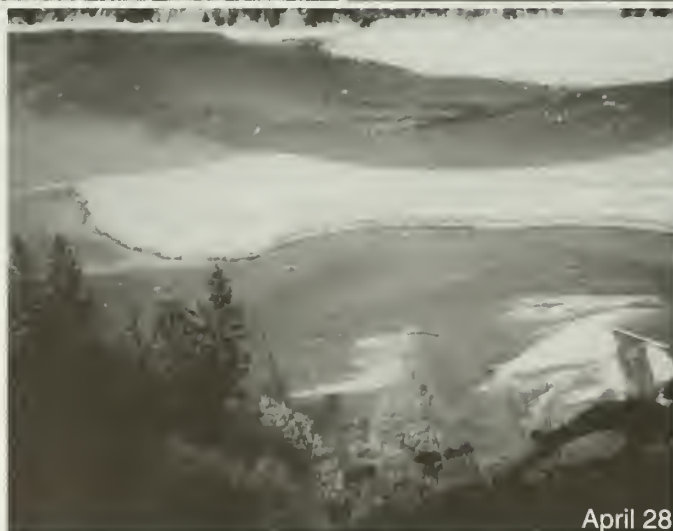
Figure 22. Time-lapse photographic sequence from camera looking at downstream reach of the delta on April 10, 14, 20, 24, and 28, 1994. Photographs provided by the National Park Service.

The repeat photography provided a visual record of delta erosion and redeposition during the drawdown and refilling of the lake. A few of these photographs are shown in figures 22, 23, and 24 to illustrate the channel development and movement during the drawdown experiment. Quantitative measurements can be made from the photographs because surveyed photo panels were placed in the image fields. The photographs were digitized and archived in photo-CD format from which a time-lapsed video was produced. The video is in three parts, one for each camera position. The video is on file at the Water Resources Division Office of the National Park Service in Fort Collins, Colorado.

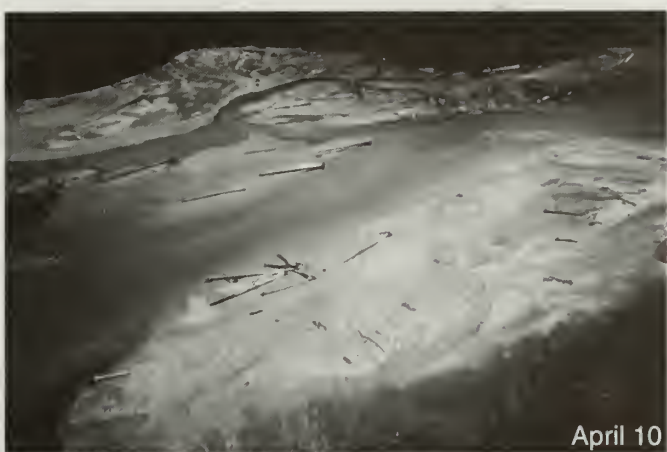
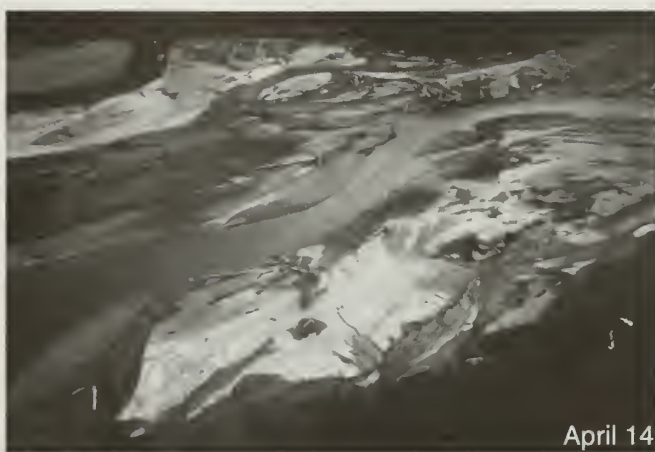
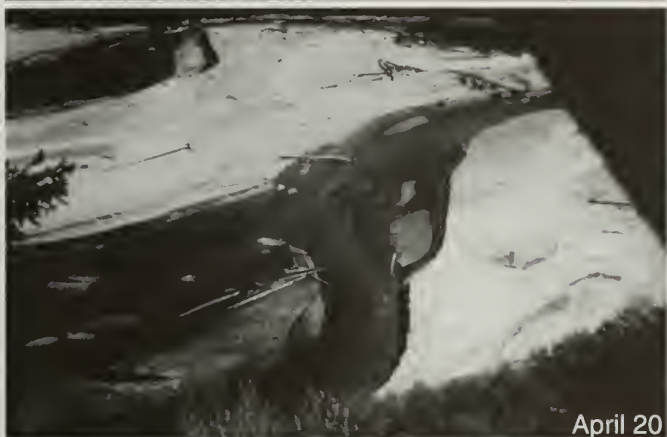
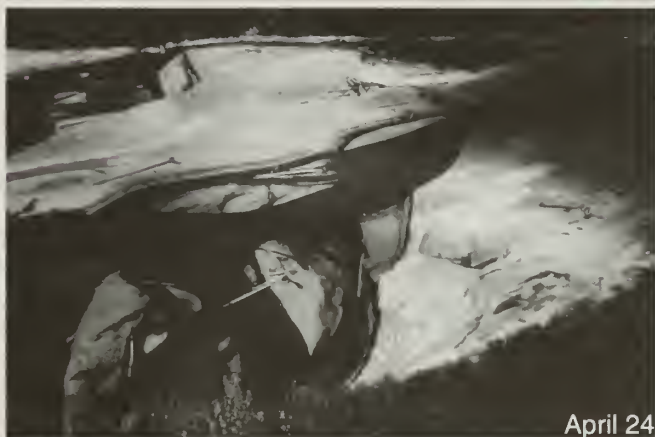
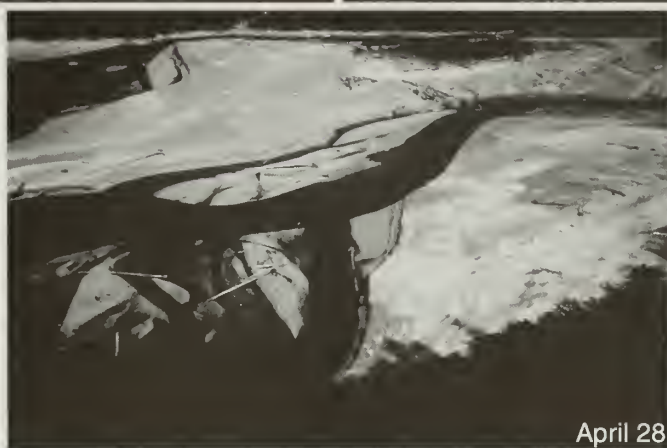
Figure 23. Time-lapse photographic sequence from camera looking at middle reach of the delta on April 10, 14, 20, 24, and 28, 1994. Photographs provided by the National Park Service.

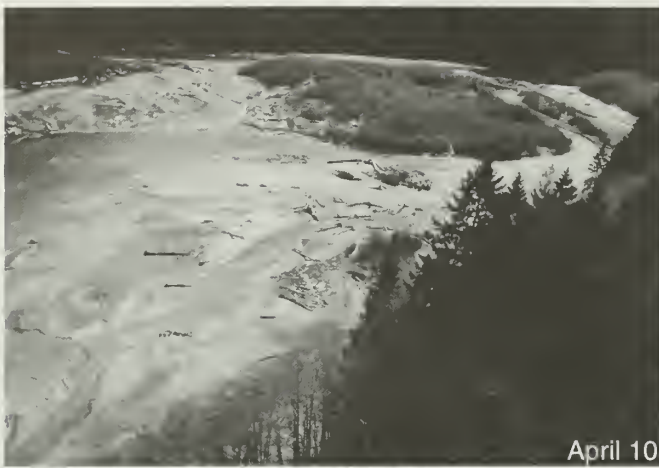
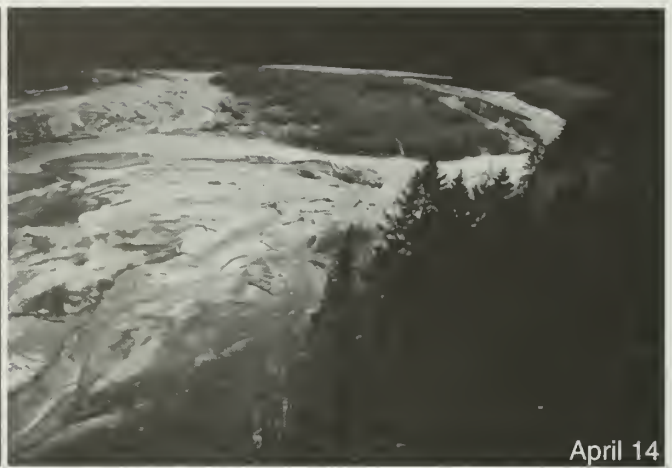
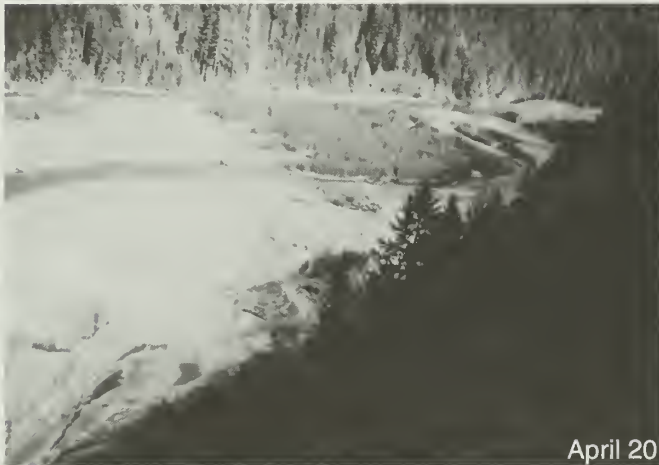
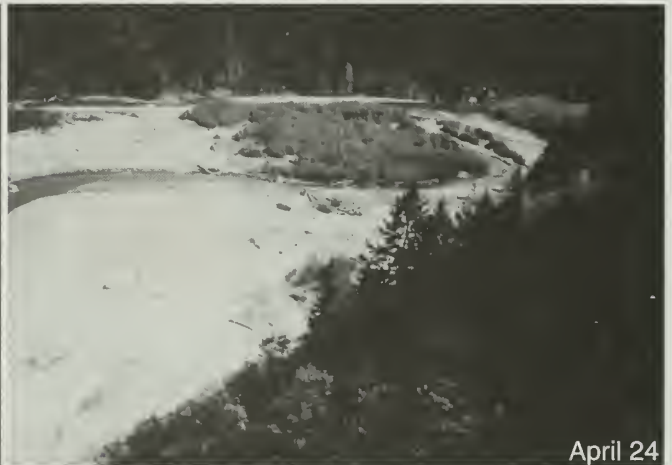
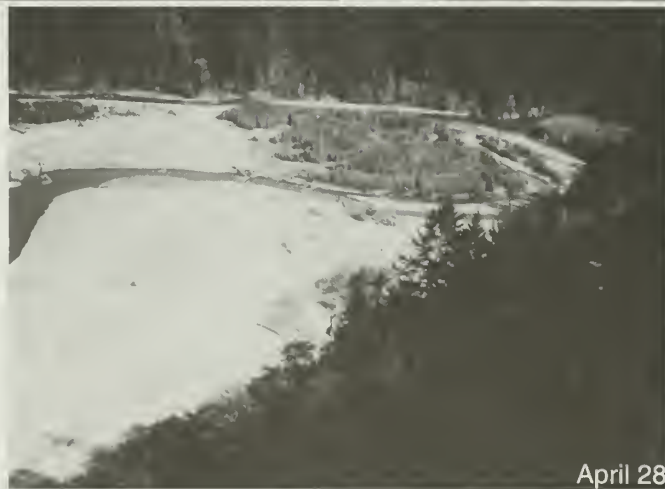
Figure 24. Time-lapse photographic sequence from camera looking at upstream reach of the delta on April 10, 14, 20, 24, and 28, 1994. Photographs provided by the National Park Service.
